The Reconstruction and Failure Analysis of The Space Shuttle Columbia

Richard Russell¹, Brain Mayeaux¹, Steven McDanels², Robert Piascik³, Sandeep Shah⁴,
Greg Jerman⁴, Thomas Collins⁵, Warren Woodworth⁶

¹NASA JSC, ²NASA KSC, ³NASA LaRC, ⁴NASA MSFC, ⁵The Boeing Company,
⁶United Space Alliance

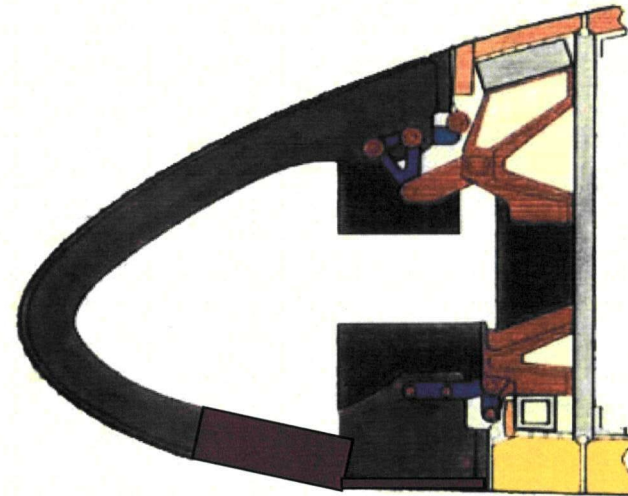
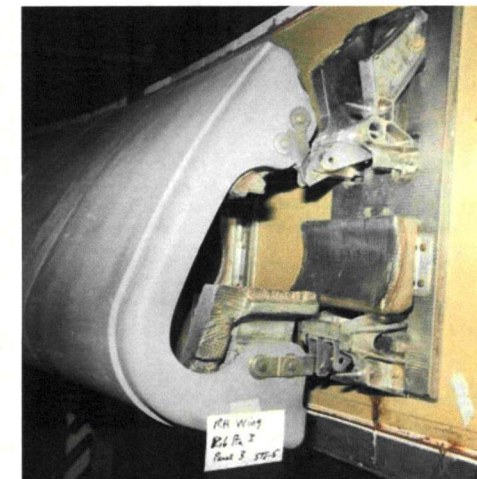
LESS Observations

- Unique indications of heat damage:
 - ◆ Excessive overheating and slumping of carrier panel tiles
 - ◆ Eroded and knife-edged RCC rib sections
 - ◆ Heavy deposits on select pieces of RCC panels

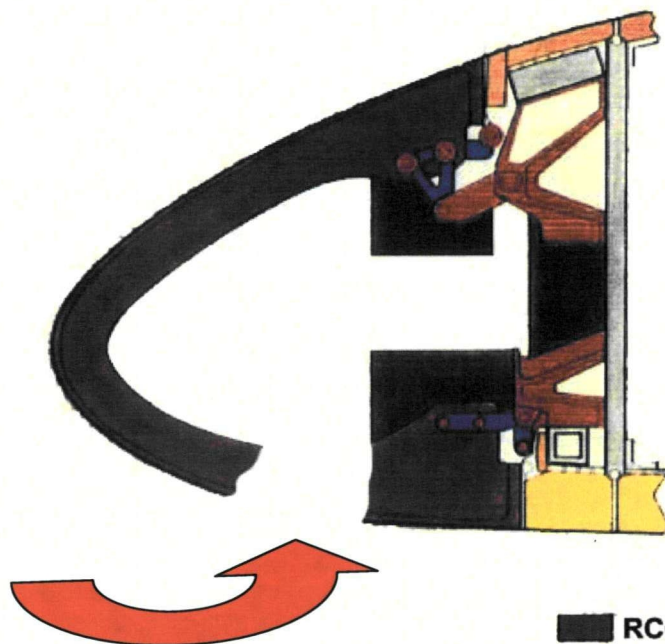
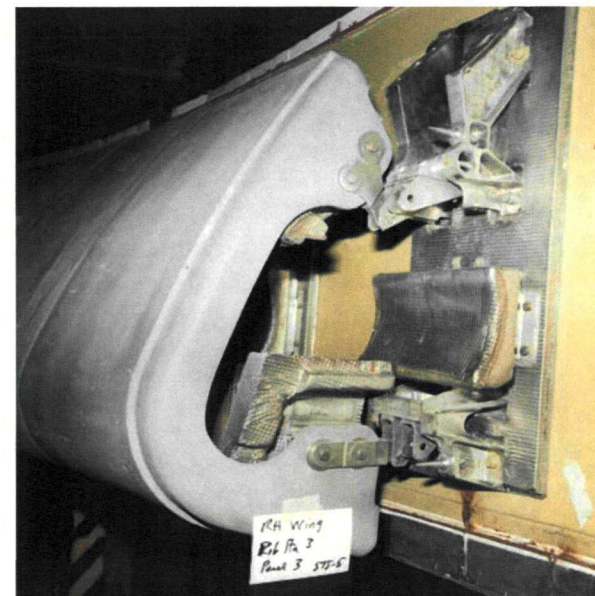
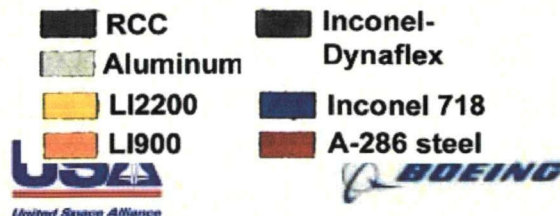
- Wing failure initiated in the panel 8 area
 - ♦ Most likely at the panel 8 area near 8-9 joint
 - ♦ Condition existed before or shortly after entry interface

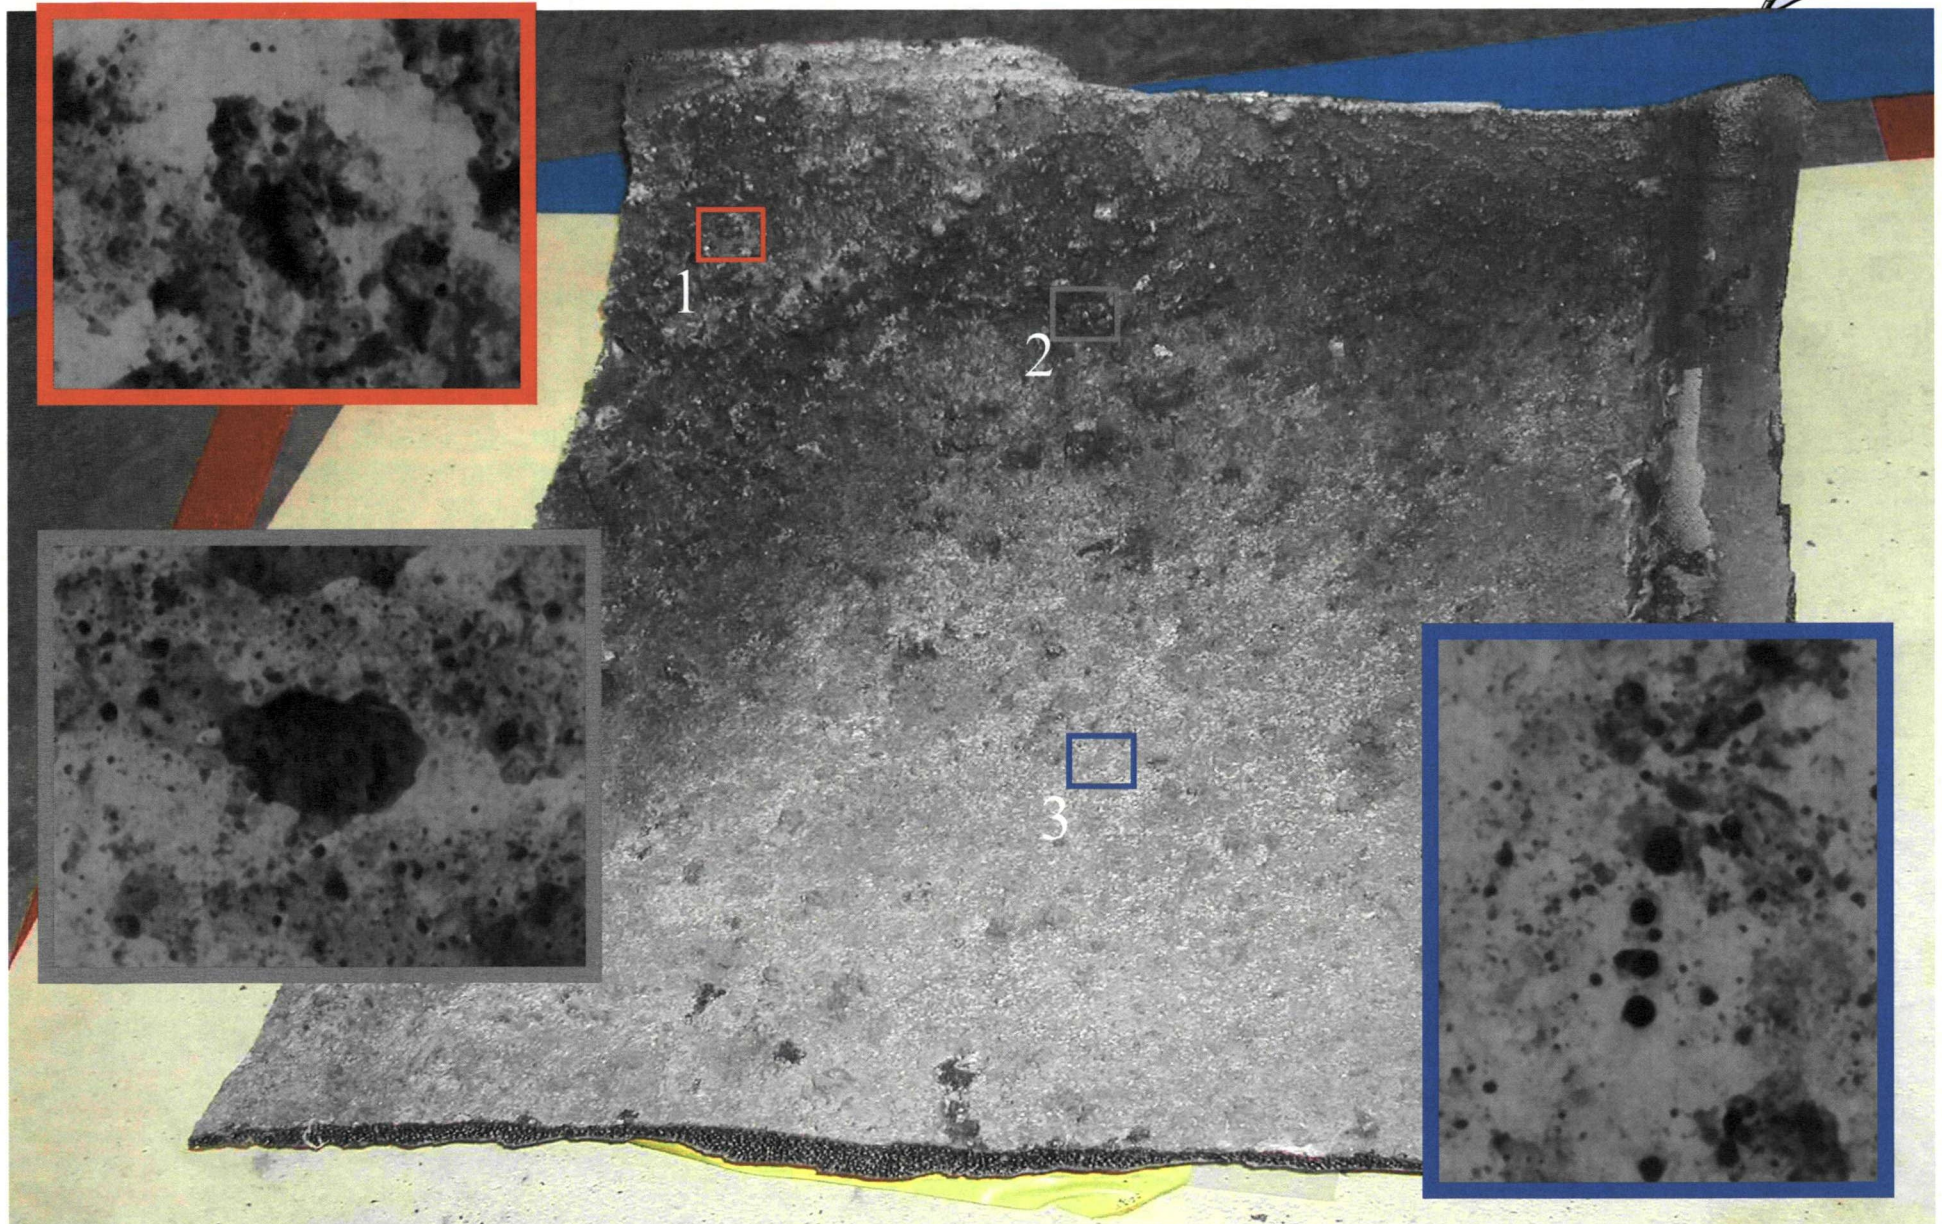
LH RCC 8 Upper Apex

- Four types of deposit patterns were identified from LH RCC Panel 8:
 - ♦ Uniformly thick; Spheroidal; Tear-shaped; Globular
